Expedition Report West Wales Wreck Exploration

Cardiff BSAC Branch 590
BEGS Grant Scheme

Rhian Lewis-James
17 December 2010

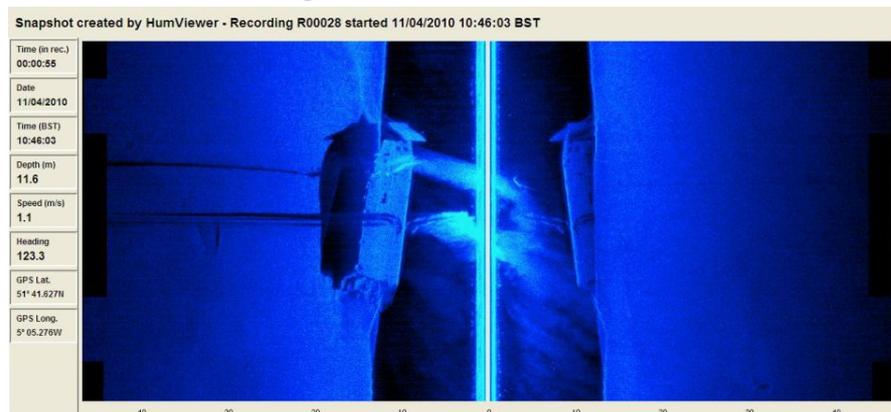
Side Scan Sonar Image

The Landing Craft is one of the first wrecks we found with the side scan sonar. We were given coordinates by local divers which were corroborated by www.wrecksite.eu. It was relatively easy to locate as it stands square off the bottom and so was easy to identify on the sonar. There is, however, very little historical information about the craft.

The Landing Craft is completely intact, which is unusual considering how close to the main Milford Haven shipping lane it sits. Wrecks are usually blown up or cleared as a shipping hazard. It is lying upside down with the landing doors bent up over the hull. On ascent you must either come back up the shot line or be careful not to drift into the shipping lane whilst using a delayed SMB.

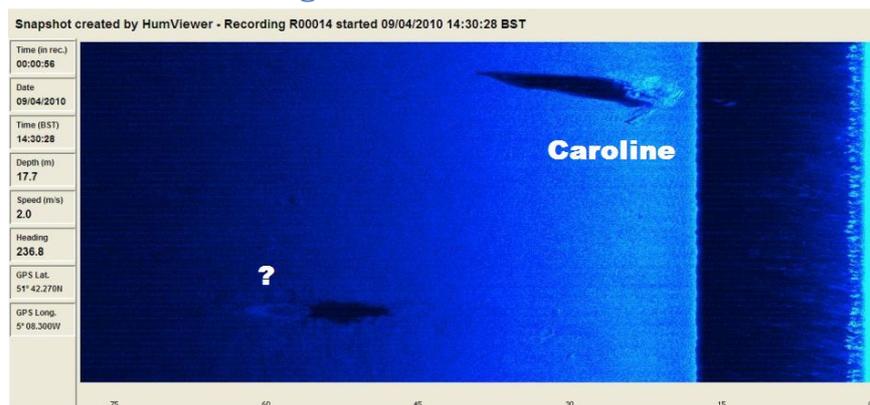
Side Scan Sonar Image

Around 50 metres from the wreckage of the *Caroline* was a shadow marked with ? on the side scan image. It turned out to be a hole in the flat seabed around 3 metres in diameter and 2 metres deep. There were pieces of aluminium protruding from the sand in the bottom of the hole. Interesting to dive to see what it was but it probably won't become a popular dive site!

The *Caroline* is the bow of a converted fishing trawler. It has been severed in two amidships. The bow structure is completely intact, despite its missing stern, and you can swim directly into the holds and much of the internal ship from the broken section. It is a very small site, good for a maximum of 4-6 divers at any one time only.

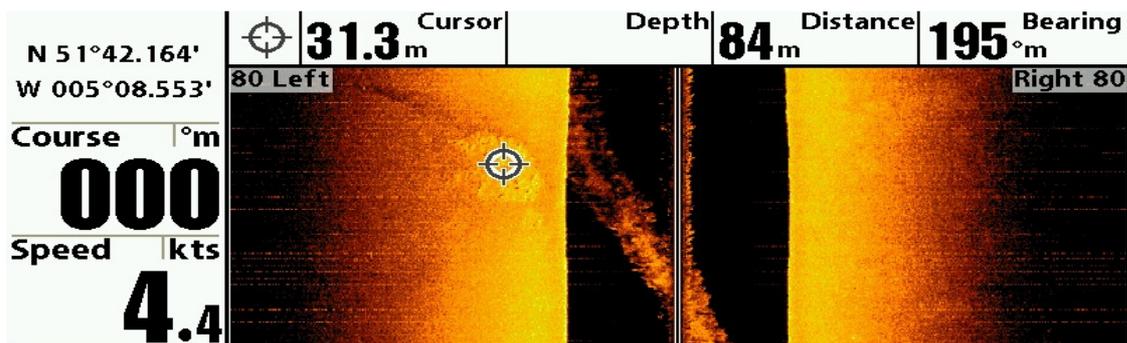
Side Scan Sonar Image

The small anomaly is under the cross hairs mark and was all we could see of the vessel.

The wreck is very broken and mangled sitting in silt. There are small pieces of china and debris which indicates it has been dived very little as it has not been pilfered. There is a large admiralty anchor lying nearby which is unlikely to be associated with the wreckage.

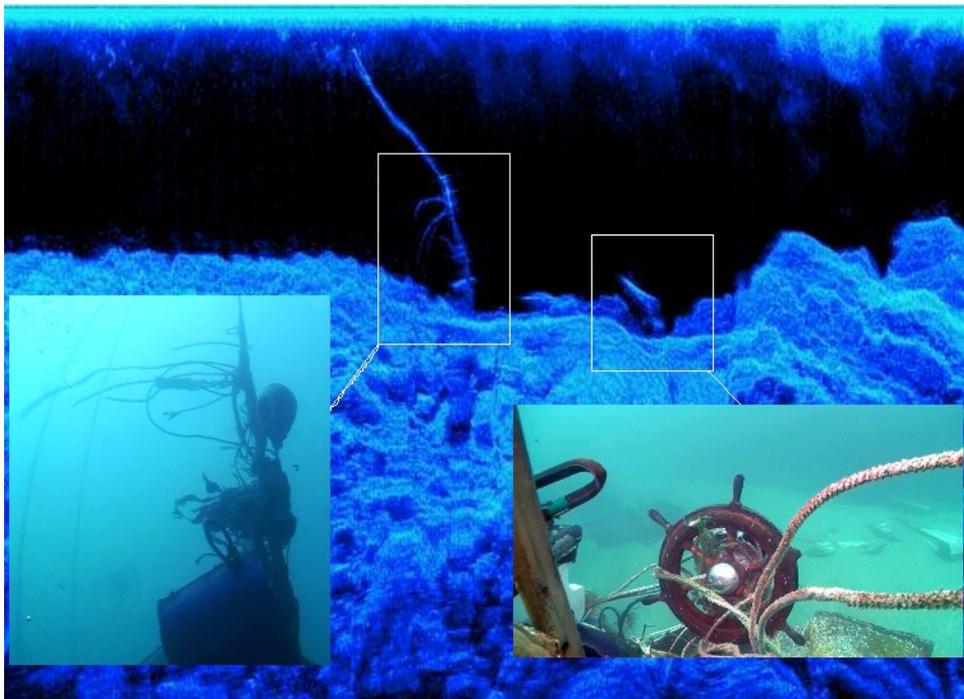
Side Scan Sonar Image

In the sonar image you can see the ropes reaching to the surface. To the right of the rope on the side scan image you can just about distinguish wreckage in the dip which appears different to the solid-looking rocks.

Scattered around a large sand hole are the remains of the *Kerloch*. Rope and fishing nets tangle with buoys and even a door as they reach to the surface. The hull has split open revealing the innards of the boat with the engine block covered with a white ooze as the chemicals react with the salt water. The brass propeller and the wheel are still attached amongst the debris and Wellington boots lie in the surrounding sand.

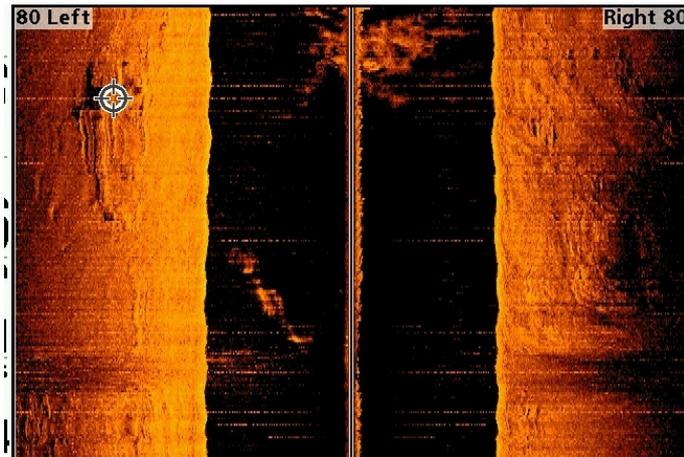
Side Scan Sonar Image

The *St Jacques* is on a sandy bottom but is quite low lying and, at 30m+, is very small on the side scan sonar. From the depth sounder it appears to have sections spread over quite a large area with some additional peaks which we have still to dive in order to find out what they are.

The cross hairs are on the centre of the wreckage.

Sitting on a sandy bottom, the large propeller sits upright attached to the drive shaft at the stern. You can follow the drive shaft easily all the way to what remains of the engine and three boilers. There is a spare propeller lying aft to starboard. Scattered amidships are pipes, which gave rise to its original name – the pipe wreck! We didn't get any further towards the bow on this dive and so need to return to dive the rest of it.

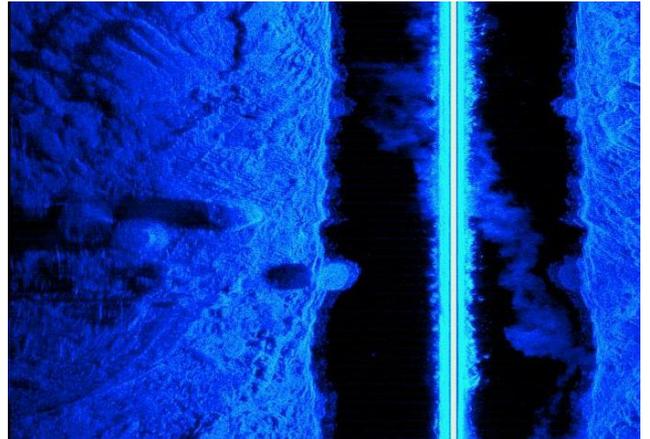
The *Nicolau Virginia* we found on the last weekend but were unable to dive it due to the tide so that is another new wreck to dive next year. To the right is the side scan sonar image showing a clear picture of the boilers at 51° 36.500' N, 005° 00.270' W.

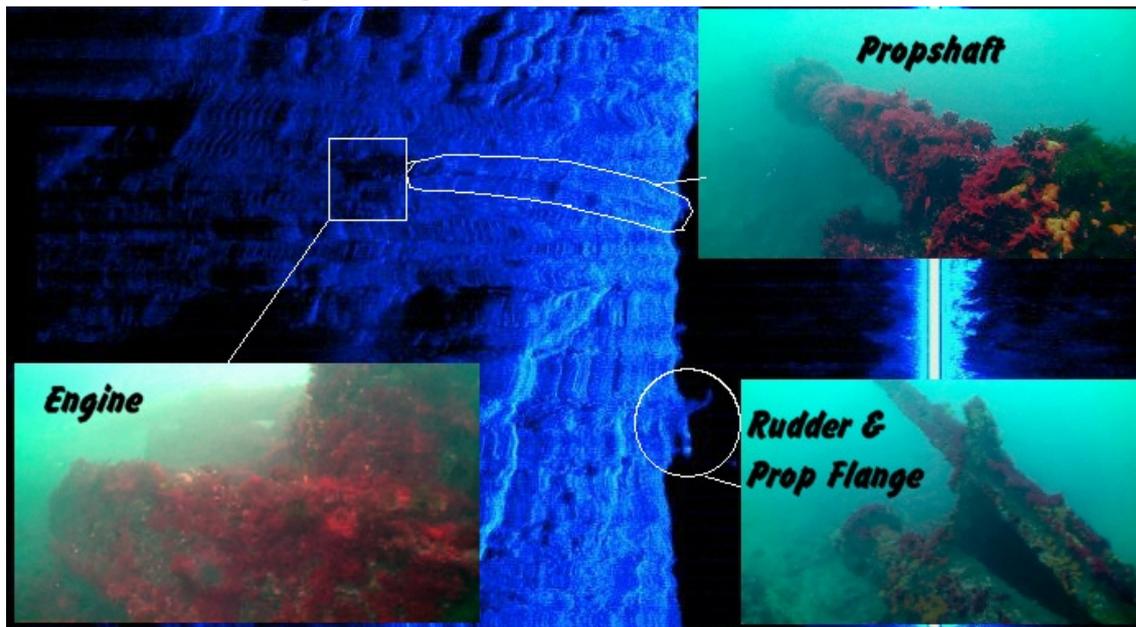
Side Scan Sonar Image

Due to the rocks surrounding the site it is difficult to identify the components. The above composite makes it much easier to identify the prop shaft engine and rudder.
